TWEED SAND BYPASSING

ADVISORY COMMITTEE MEETING

17 November 2021

PROJECT MONITORING AND OPERATIONAL OVERVIEW

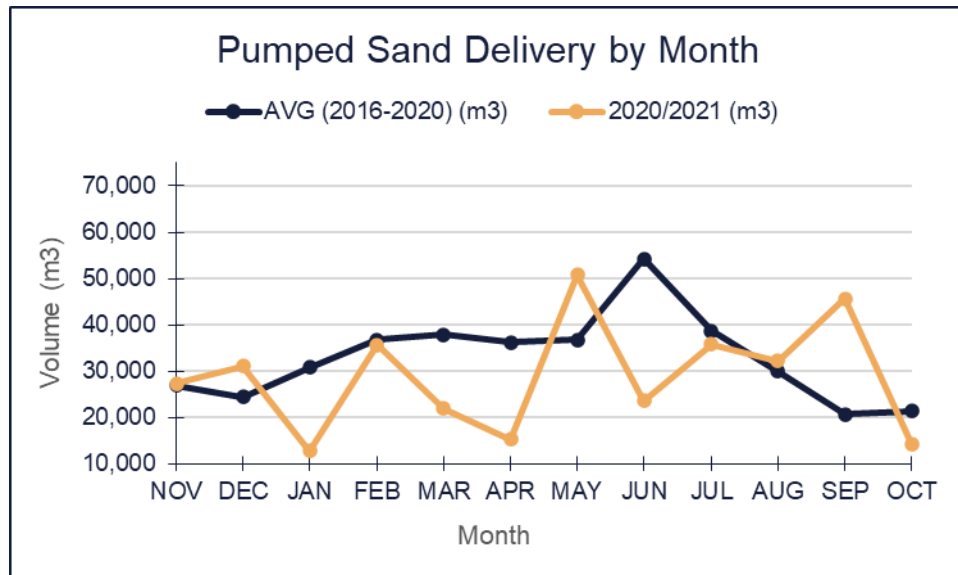
PUMPING MONTHLY TRENDS

- Sand delivery to SRE was very low in Mar and Apr due to ongoing nourishment efforts directed to Duranbah – this was in attempt to replenish Duranbah beach to volumes similar to the pre Dec 2020 storm event.
- Overall volumes since Jan have generally been at or lower than average with the exception of May and Sep.

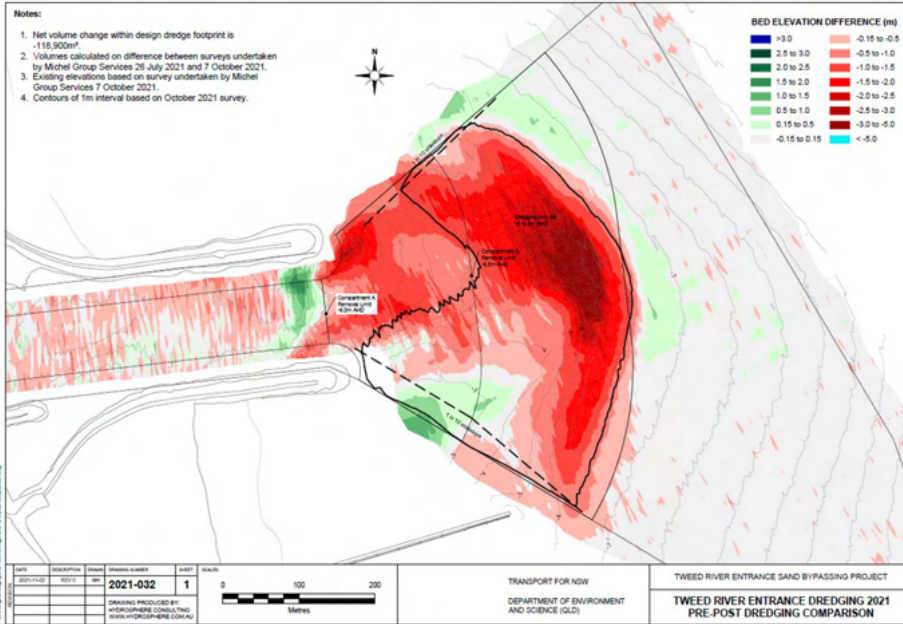
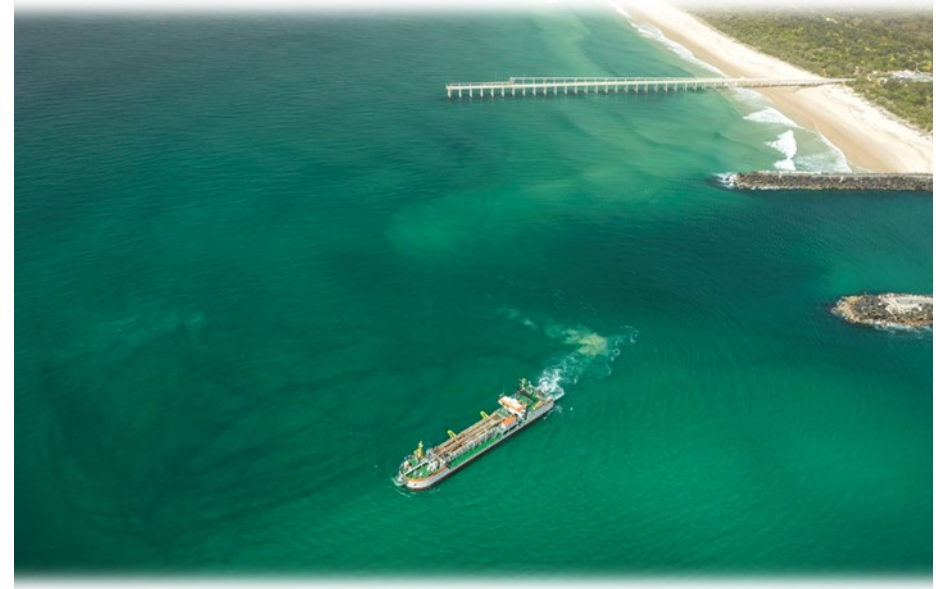
Pre and post survey comparison

- A compliant entrance was available at the end of the dredging campaign.
- The isopach figure on the left shows where sand was removed (red shading) and where sand accreted / built up (green shading) before and after the dredging campaign this year.
- Overall, a large volume of sand was removed from the entrance area depicted by the solid lines fanning out eastward from the entrance walls.
- The southern side of the entrance remains an area under close surveillance via monthly hydrographic survey – the dredge vessel was constrained by metocean conditions at the time in targeting this area.

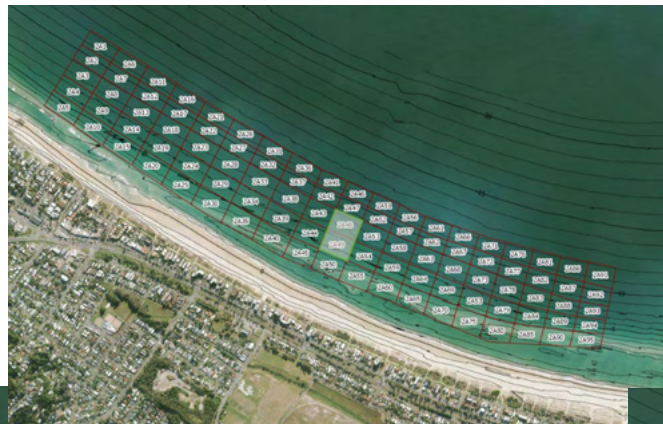
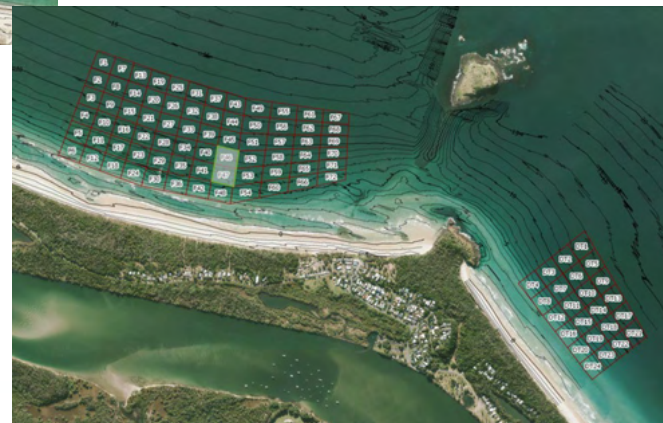
Snapper Rocks and Duranbah

- The shaded boxes show where dredged sand was placed. The table on the bottom left shows the volumes placed at each of the placement areas.
- The removal and placement design was based on volumes up to 165,000m³. Due to reasons beyond the governments control, the placement volumes defined for each area were not fully realised, however a volume of 133,316m³ was achieved.
- The placement design was adjusted throughout the campaign to ensure sand was distributed appropriately with the available volume.

Location	Vol (m3)
Bilinga	14,729
Snapper Rocks	59,061
Duranbah	52,181
Fingal Heads	7,345
Total	133,316

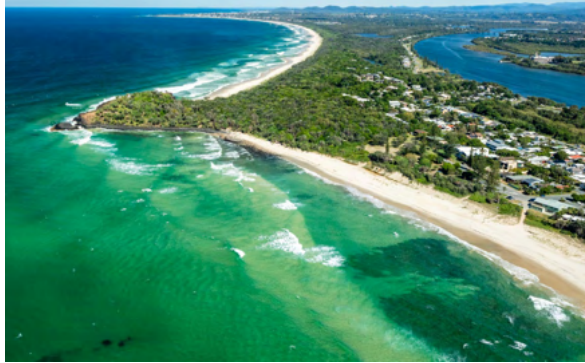
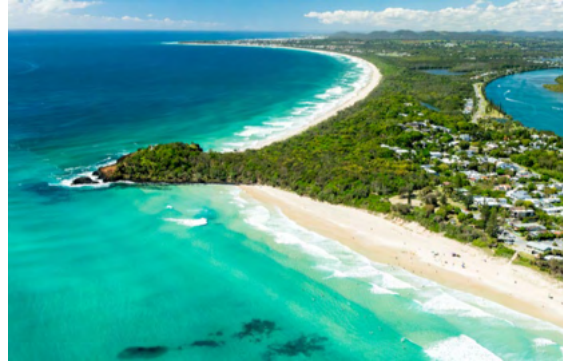
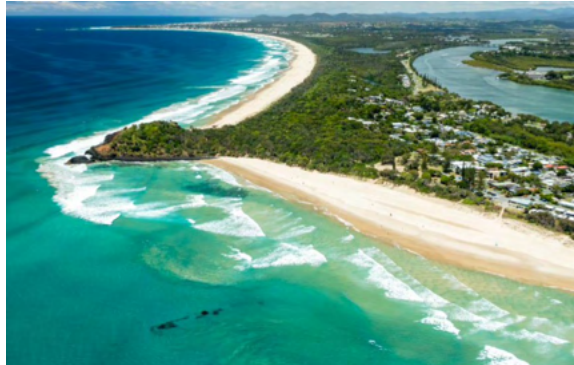
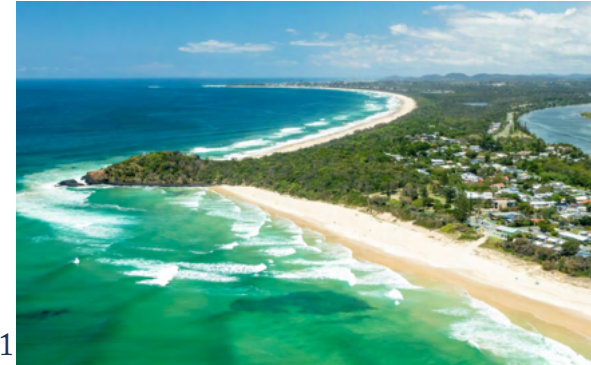
FINGAL

- Consistent with any east coast headland set up in Australia, episodic movement or bursts of sand move around Fingal head when the northern most area of Dreamtime beach becomes full. Oct 2020 shows a semi depleted down drift (northern) side of Fingal beach, with October 2021 showing a naturally replenished beach.
- April 2020 had the largest observed beach width during this period.

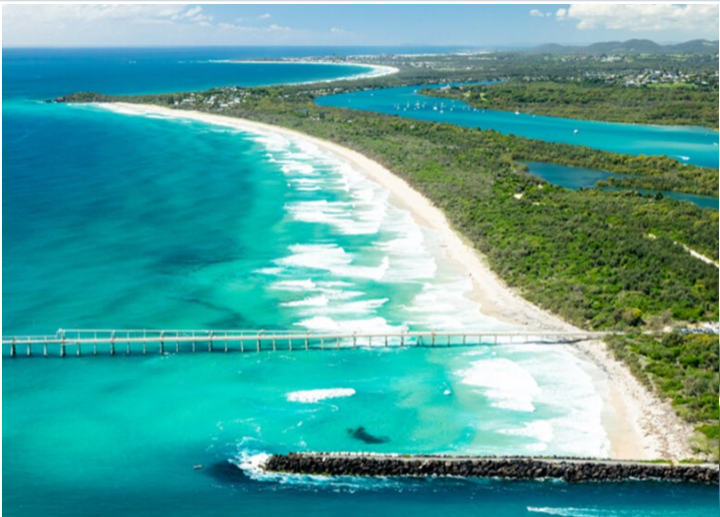
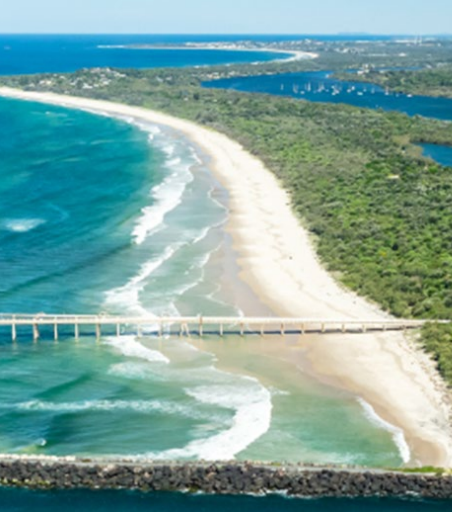
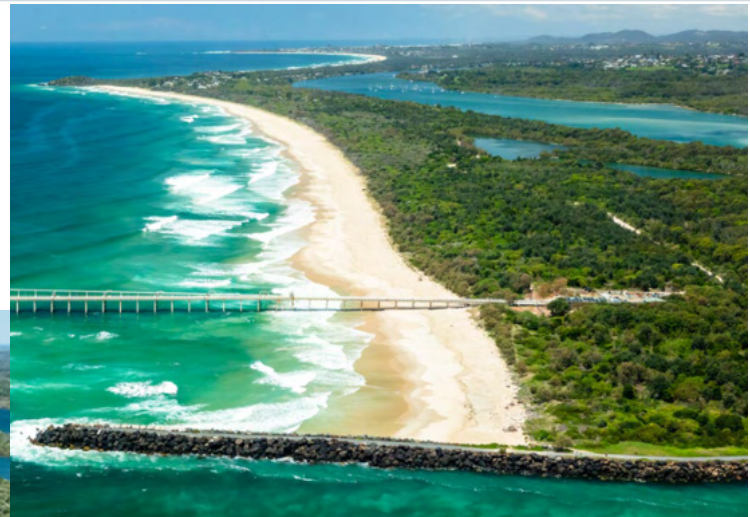
LETITIA

- Insignificant change along Letitia from Jan – Oct, with the period exhibiting signs of a recovering beach from the Dec 2020 storm event. This can be noticed at the jetty itself between Jan – Oct 2021.
- Beach widths in general have grown through natural accretion or beach building processes.

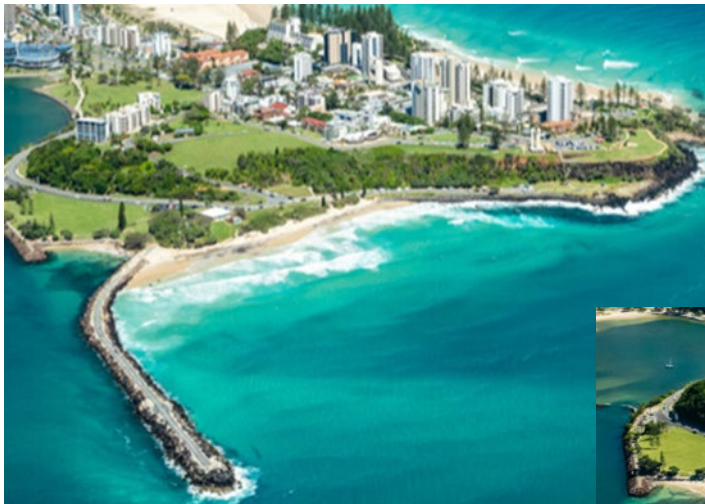
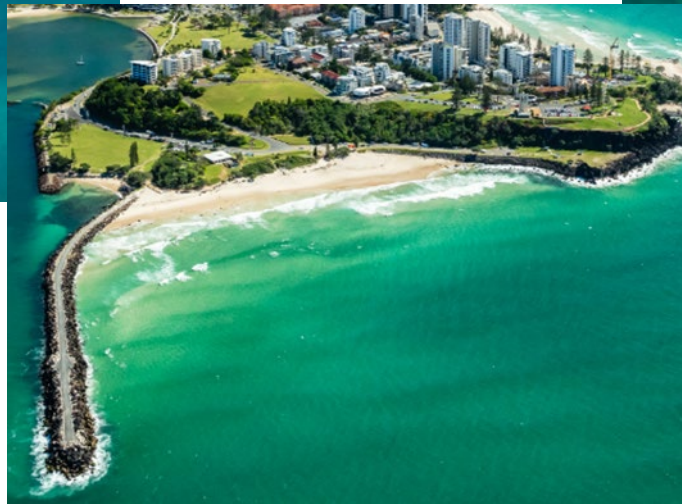
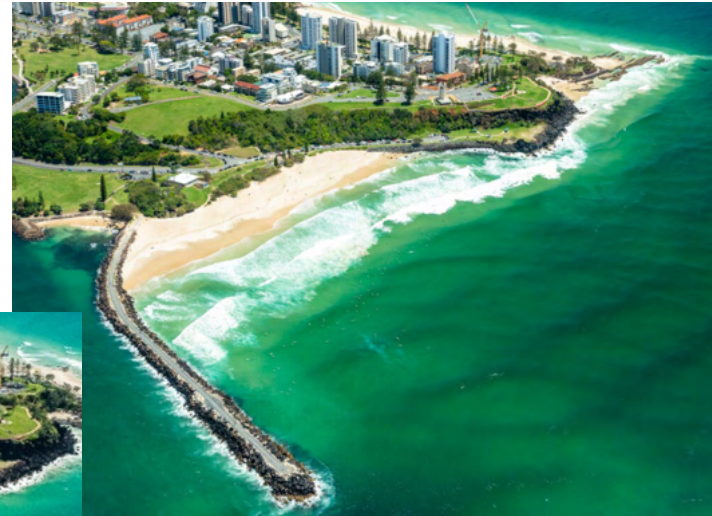
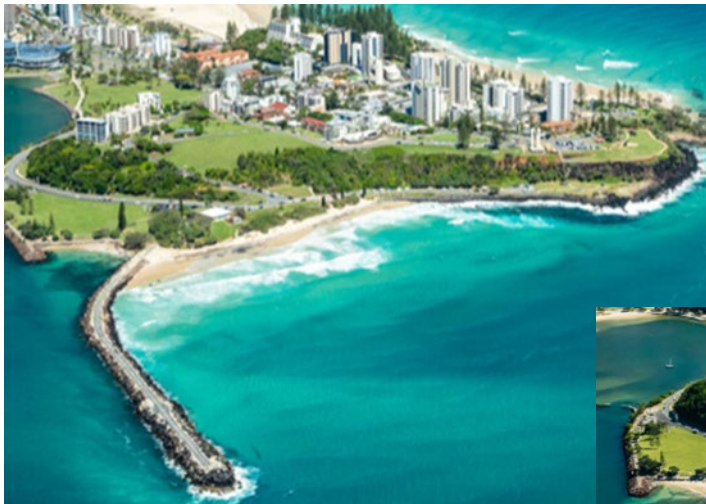
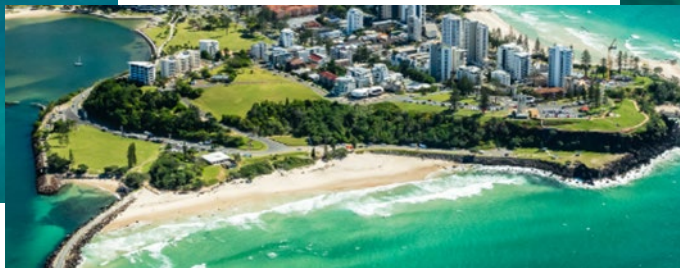
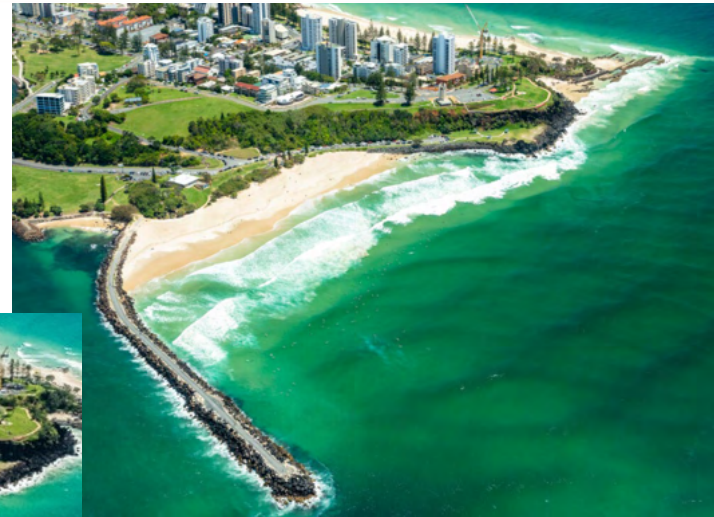
DURANBAH BEACH

- Duranbah during this period underwent a significant nourishment campaign
- Duranbah post Dec 2020 storm event into January was severely depleted (eroded).
- Duranbah has responded well to the nourishment, naturally sorting the profile and remains healthy at present.

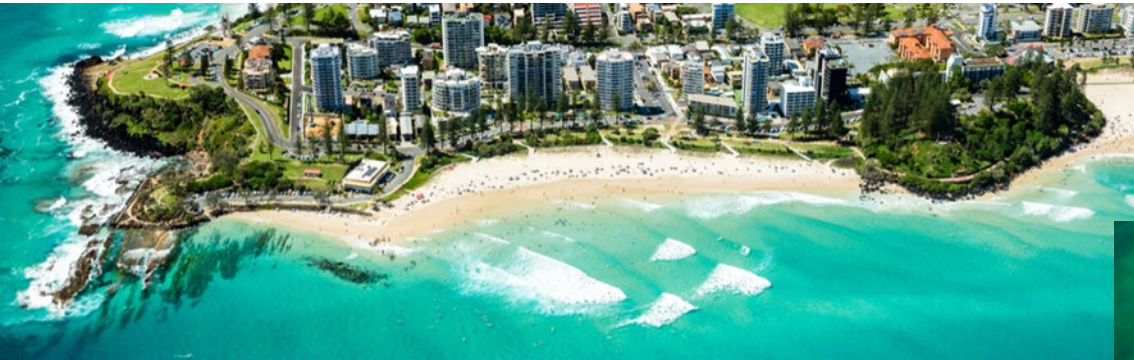
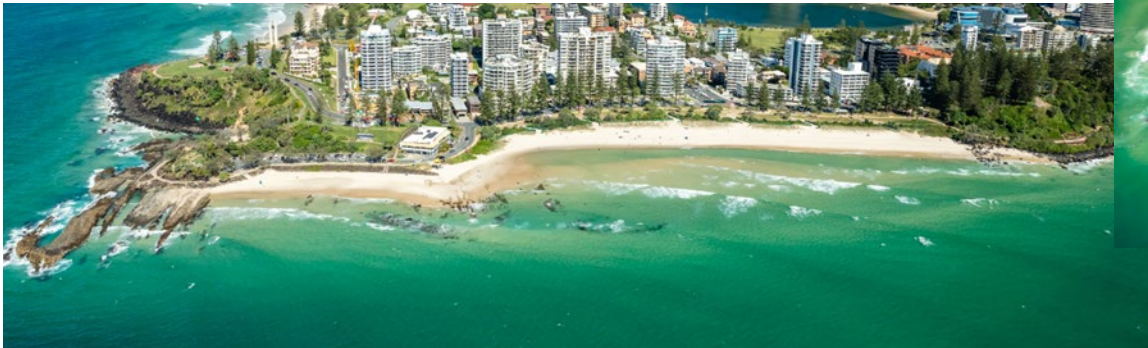
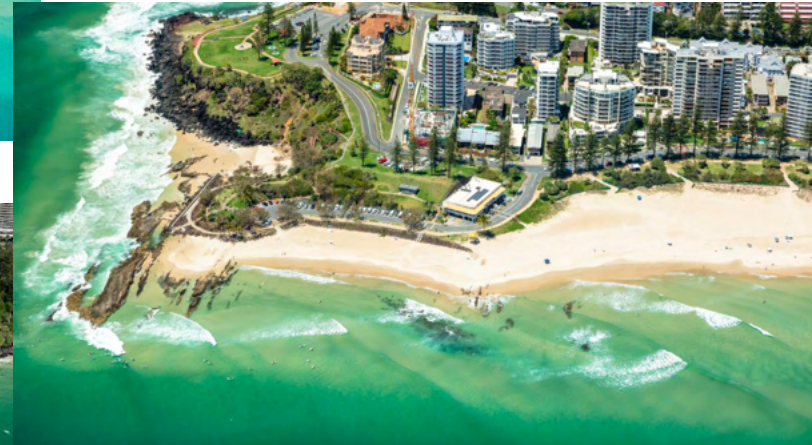
SNAPPER ROCKS RAINBOW BAY

- Similar to other areas south, the December 2020 storm event removed large quantities of sand from Froggies and Snapper rocks areas, Rainbow through to Greenmount has remained healthy, with ongoing replenishment of the updrift areas (Froggies and Snapper) addressed through pumping operations.

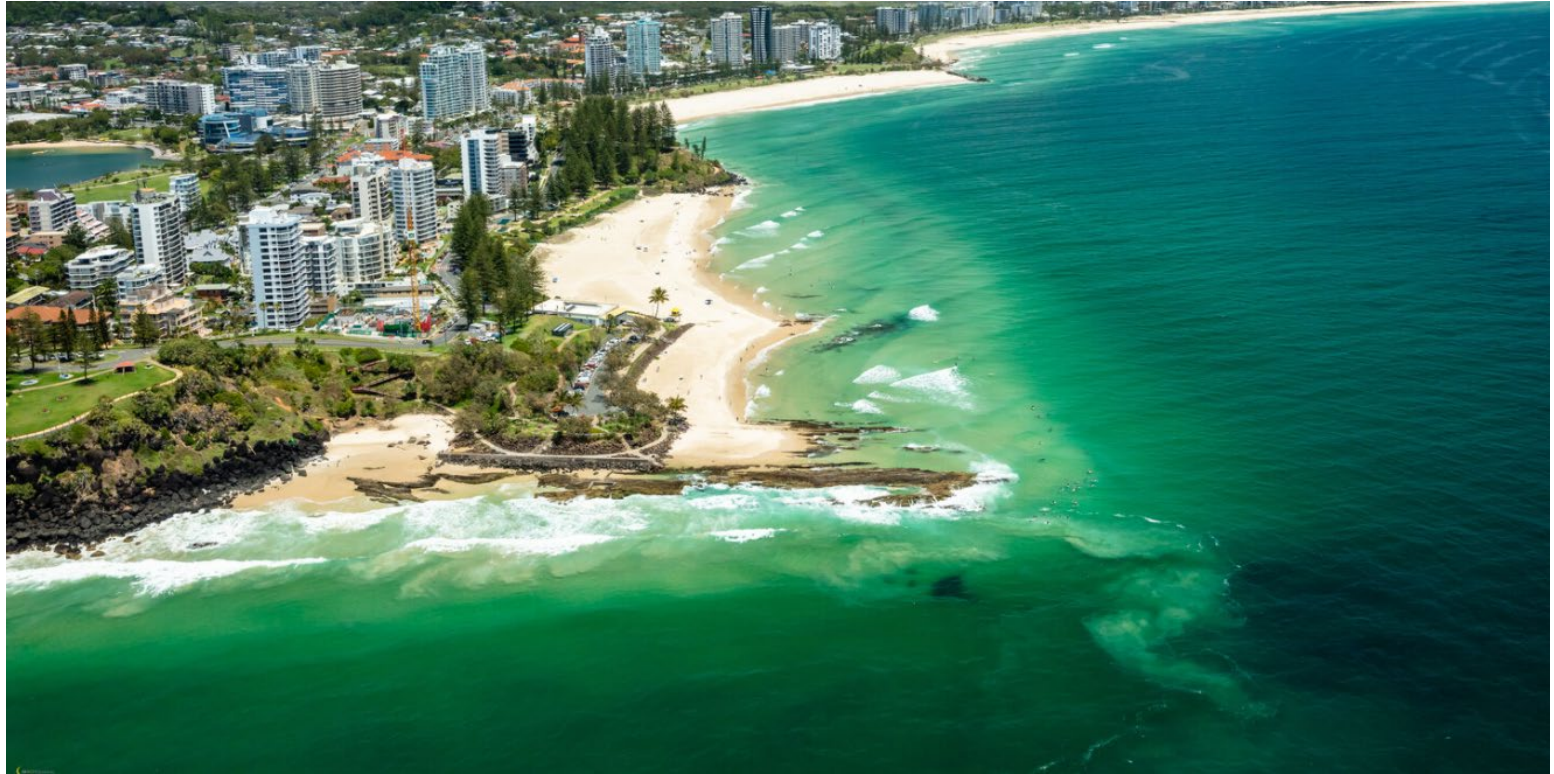
27 October 2021

- **Froggies largely replenished leading to the establishment of the typical sediment transport pathway around the back of Snapper rocks and into the Rainbow Bay embayment – note the suspended sediments**
- **Note the concentric / zeta type formations of Rainbow Bay.**

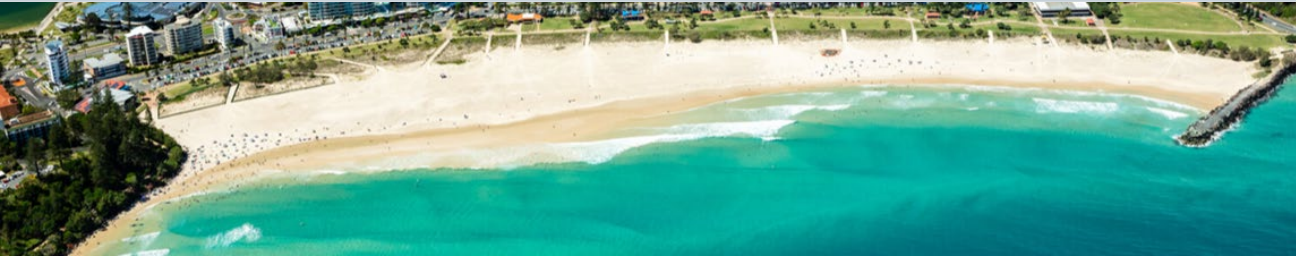
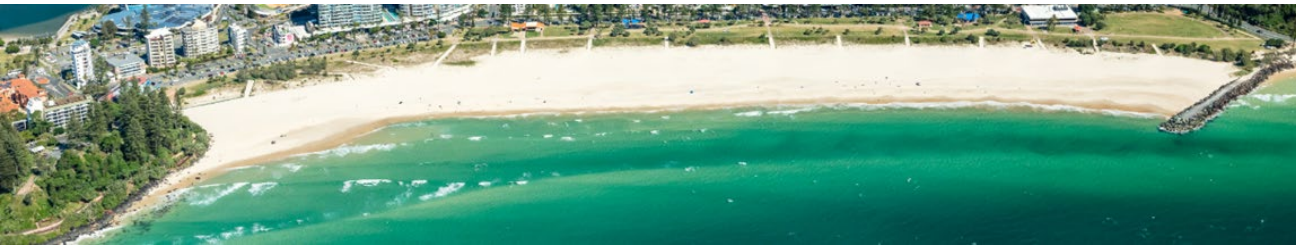
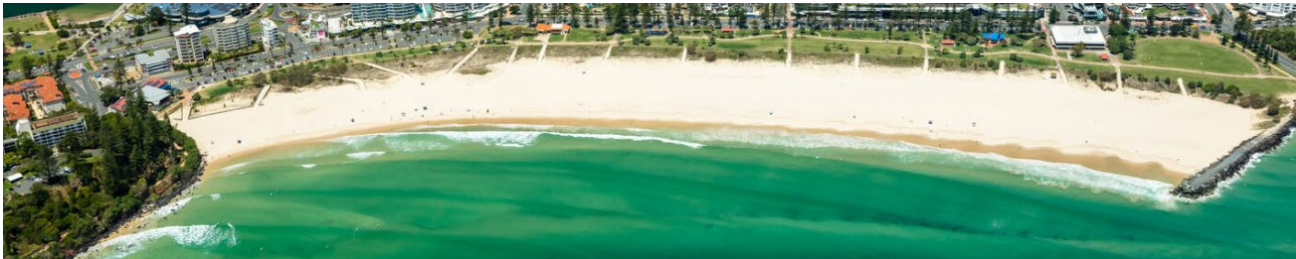
COOLANGATTA

- **Minimal change through Coolangatta bay, seasonal beach rotation can be observed; very stable, consistent with the low energy conditions through the year and the natural sheltering offered by the broader Rainbow Bay embayment and Greenmount headland.**

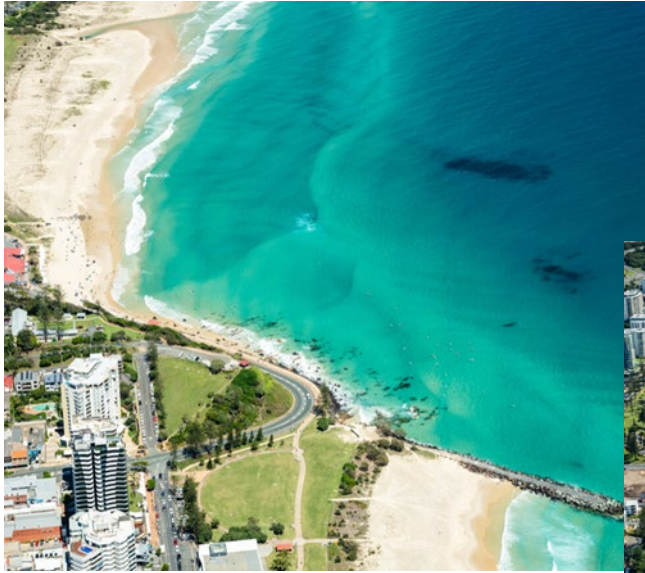
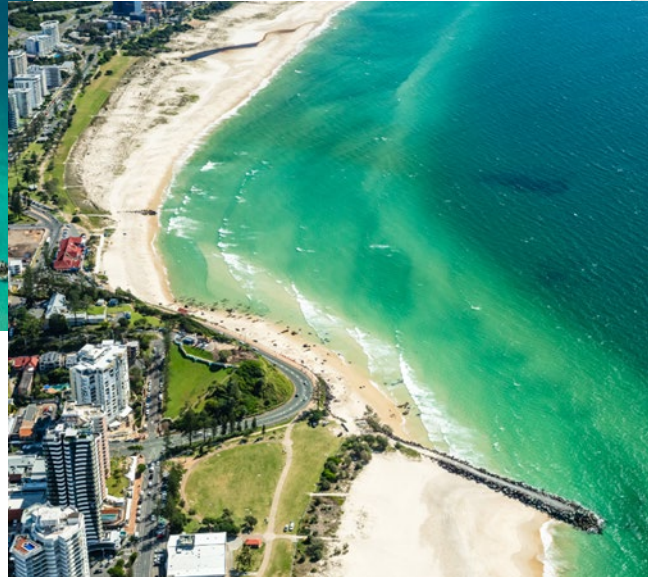
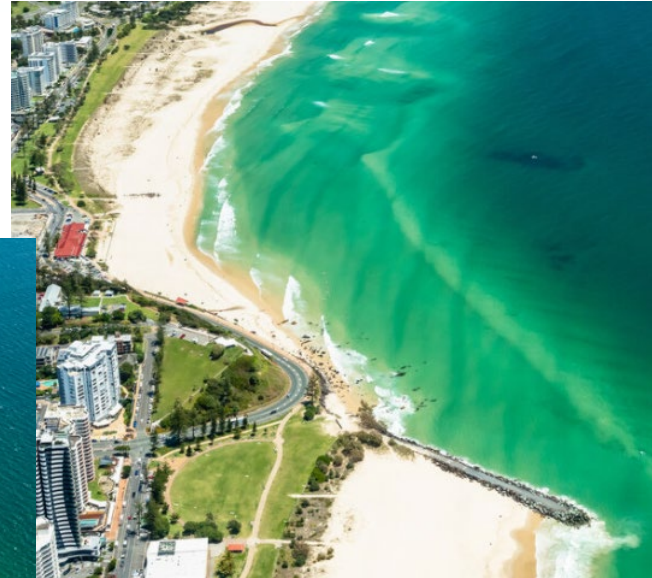
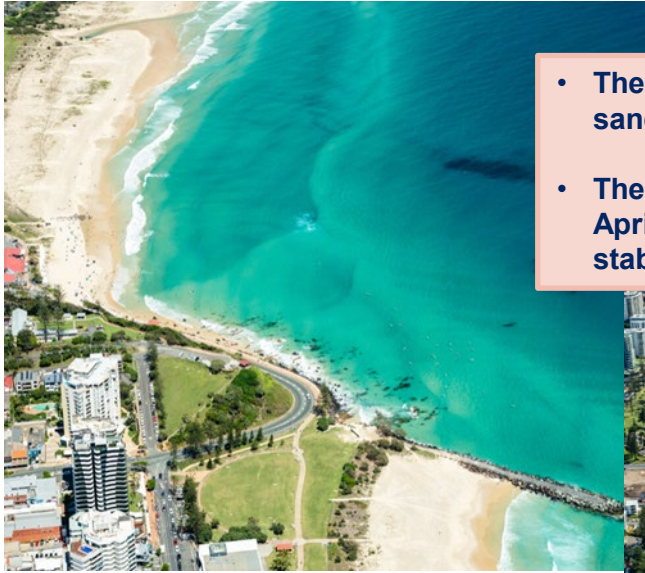
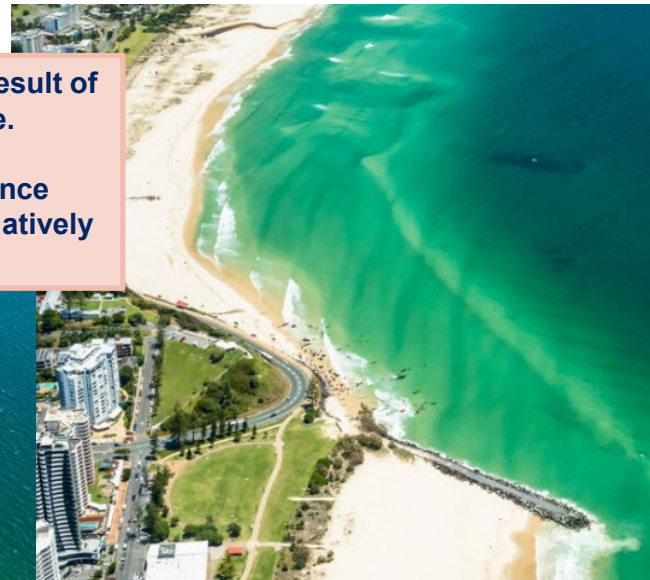
KIRRA

- The upper beach at Kirra has recovered as a result of sand build up and bypass around Kirra groyne.
- The bank has become slightly more defined since April although position and angle has been relatively stable

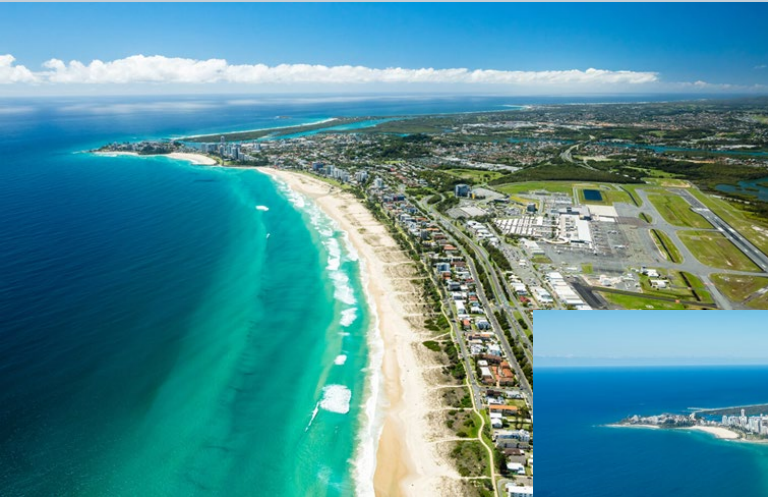
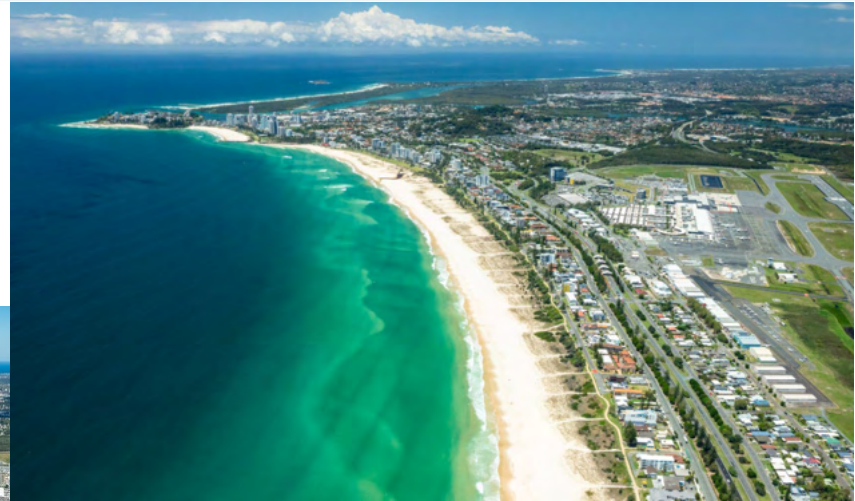
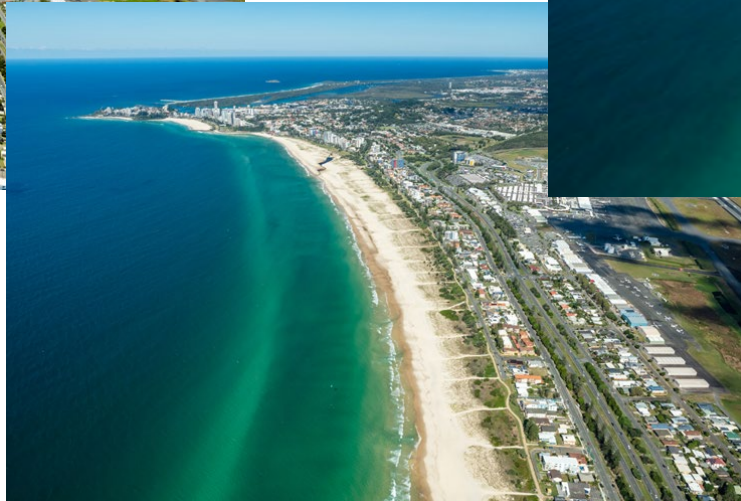
BILINGA

- January a notable bold storm bar offshore as a result of the December 2020 storm event. Large trough evident between beach and the offshore storm bar.
- In April this storm bar is less pronounced as it begins to move cross shore toward the land. Large trough still evident.
- A result of low energy periods, the October image depicts a more transient bar formation, with variability throughout. The offshore bar system is breaking up.

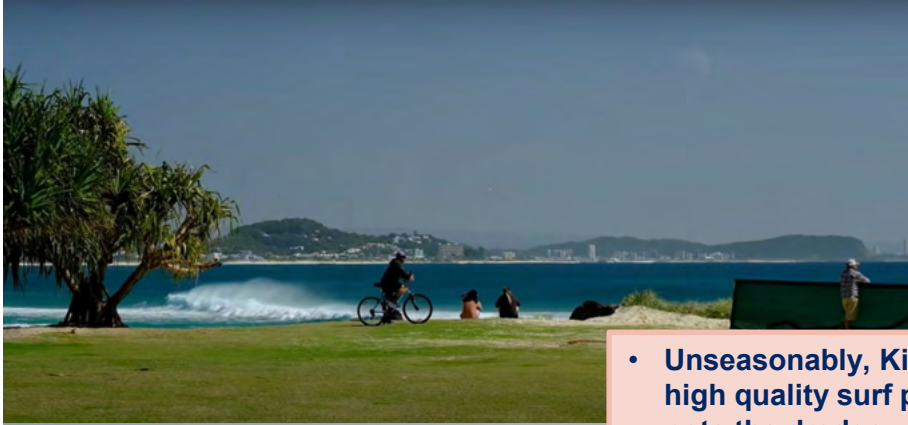
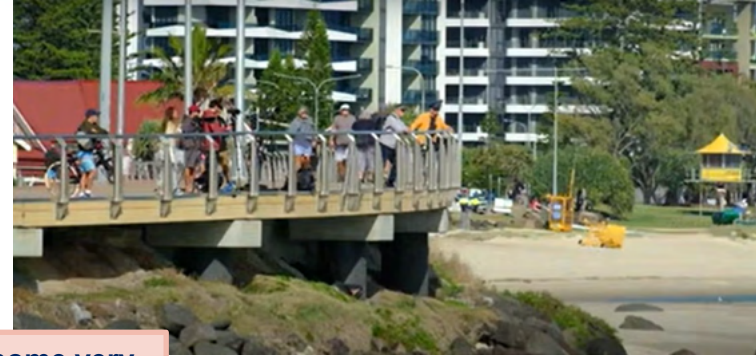
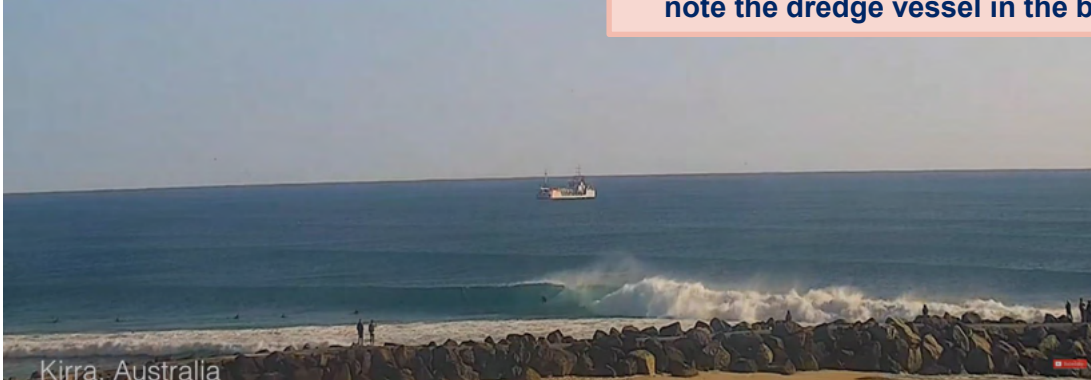
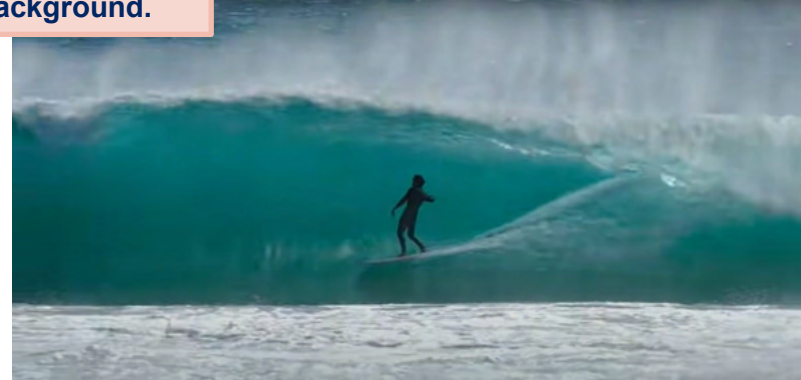
KIRRA

- Unseasonably, Kirra experienced some very high quality surf periods in September – note the dredge vessel in the background.

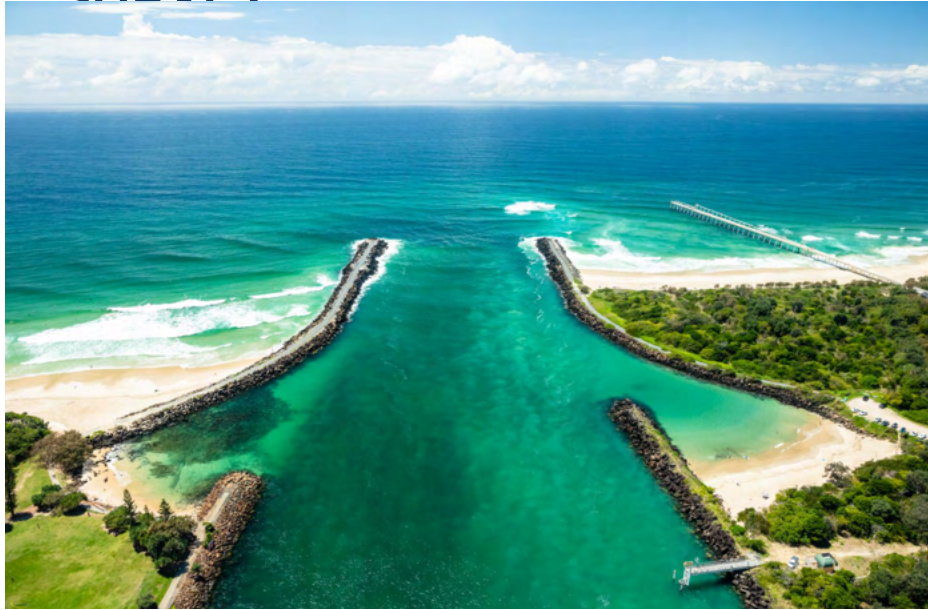
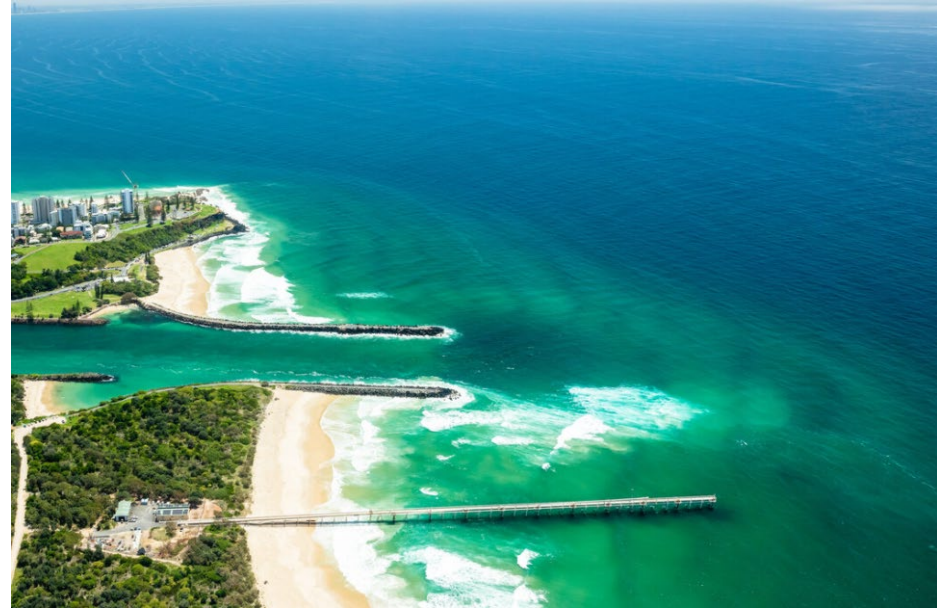
- Observations of the entrance post-dredging show the impact on sand removal across the bar
- Suspended sediment can be observed where waves are breaking on the remainder of the entrance's southern shoal

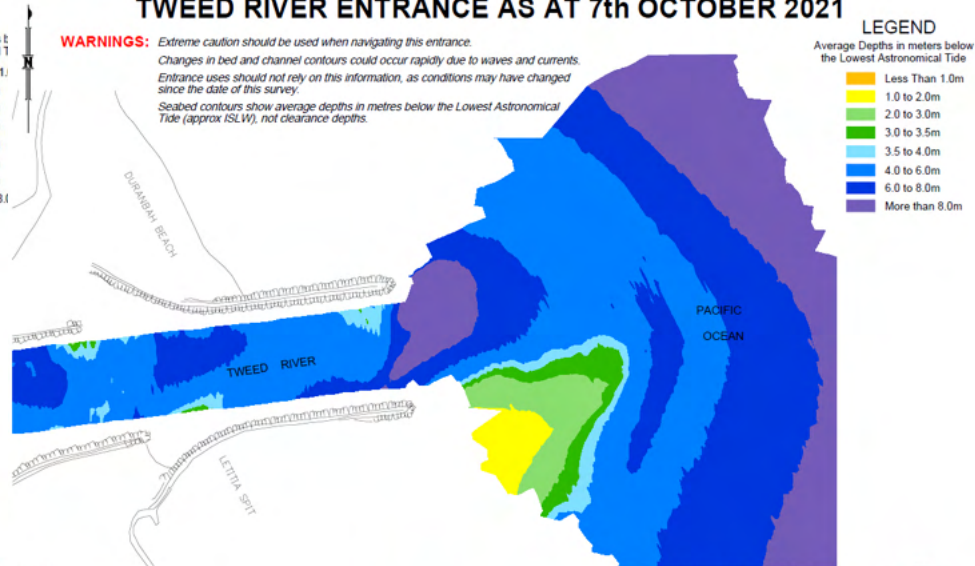
TWEED RIVER ENTRANCE AS AT 7th OCTOBER 2021

WARNINGS: Extreme caution should be used when navigating this entrance. Changes in bed and channel contours could occur rapidly due to waves and currents. Entrance uses should not rely on this information, as conditions may have changed since the date of this survey. Seabed contours show average depths in metres below the Lowest Astronomical Tide (approx ISLW), not clearance depths.

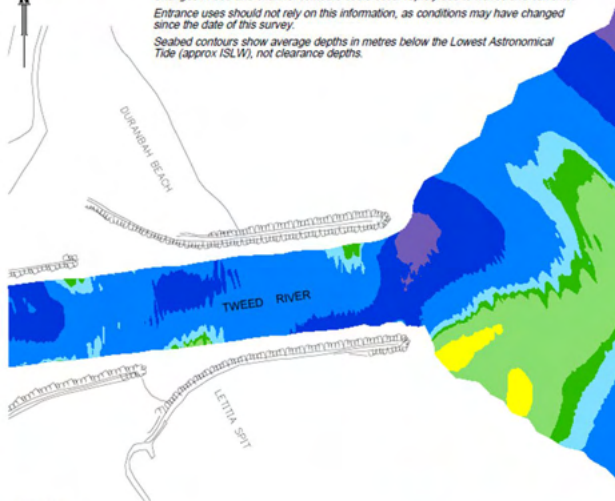
TWEED RIVER ENTRANCE AS AT 26th JULY 2021

- A clear navigation channel has been maintained after dredging of the entrance
- The bar has been broken up with the a general increase in depth across the northern and central sections of the entrance
- It is expected that the shallow southern shoal will disperse across the entrance, dredging has ensured the bar will take some time to re-establish

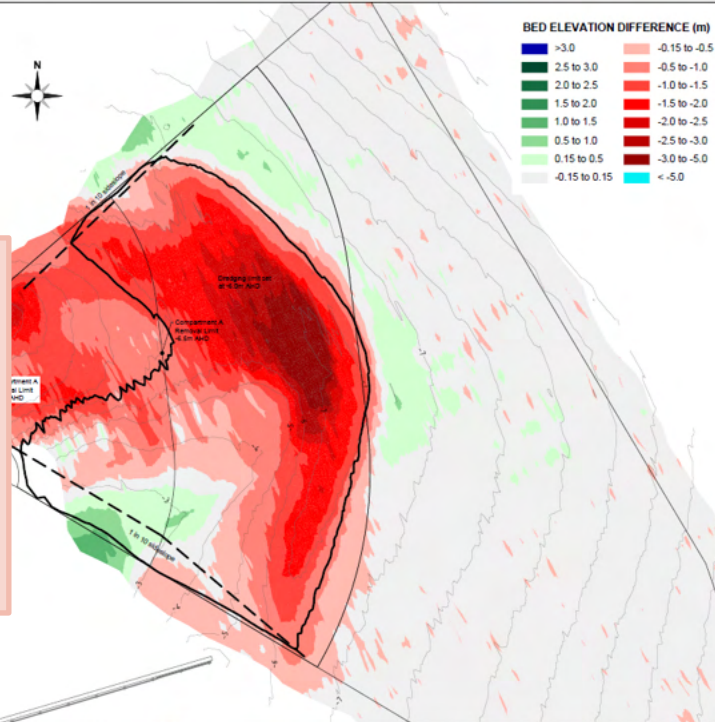
BED ELEVATION DIFFERENCE (m)

1. Net volume change within design dredge footprint is -118,900m³.
2. Volumes calculated on difference between surveys undertaken by Michel Group Services 26 July 2021 and 7 October 2021.
3. Existing elevations based on survey undertaken by Michel Group Services 7 October 2021.
4. Contours of 1m interval based on October 2021 survey.

- Red indicates a reduction in sea bed depth, green is an increase
- Overall across the entrance sand volumes were reduced and depths increased
- Due to the timing of entrance surveys, the figure is showing in some places the natural sediment transport across the southern shoal post-dredging

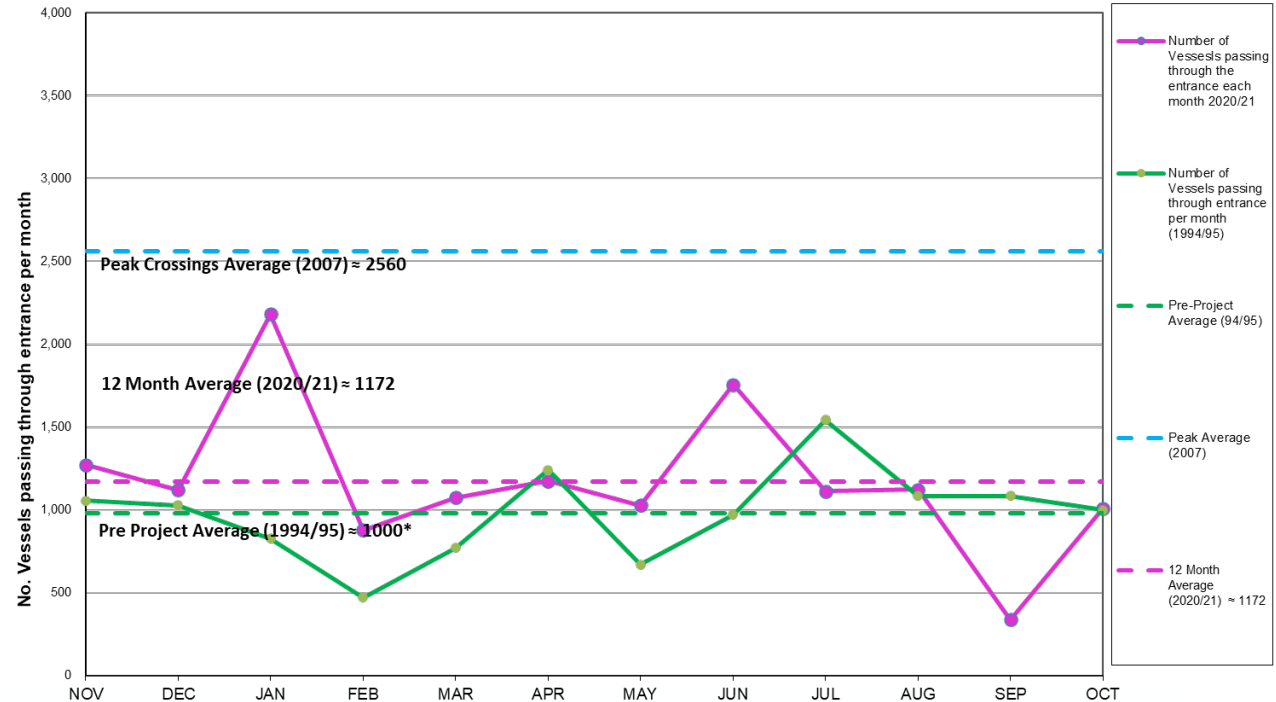
- Generally vessel passing numbers have been at or above pre-TSB levels
- September was uncharacteristically low, as evidenced by the many low VMR navigation ratings for days of Sep

Comparison of the number of vessels passing through the entrance per month 2020/21 compared to 2007 (peak crossings) and 1994/95 (prior to entrance improvements)
