AC Meeting – 18 August 2021

TWEEDSAND BYPASSING

- Project Monitoring / Operational Overview
 - Sand bypassing system operations
 - 2021 Dredging Campaign
 - Environmental Monitoring / beach observations
 - Entrance conditions, usage and survey
 - TSB projects and enhancements
 - Communications

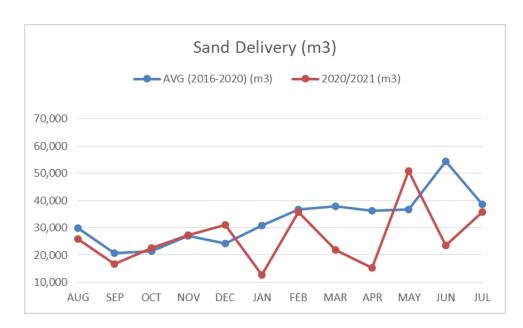
Pumping monthly trends

Avg Vol Jan to July = 271,373m3 Vol since Jan 2021 = 195,496m3

Avg Vol Aug to July = 394,684m3 Vol since Aug 2020 = 319,315m3

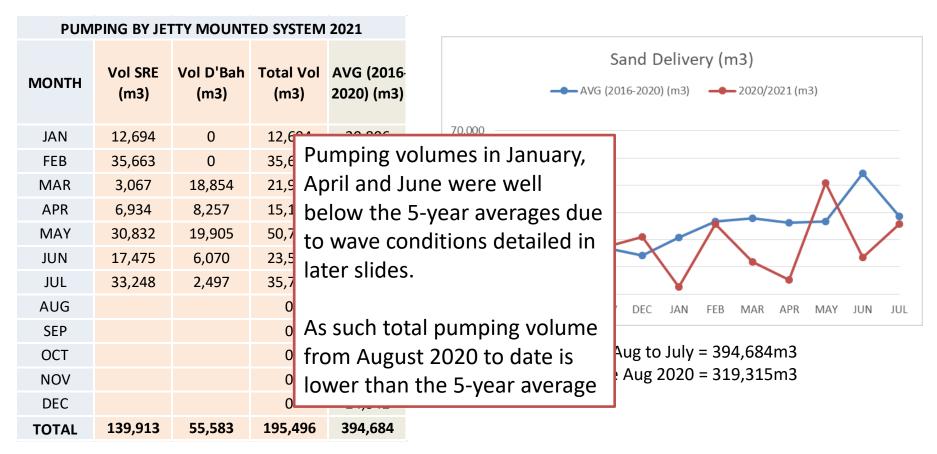
Pumping monthly trends

Avg Vol Jan to July = 271,373m3 Vol since Jan 2021 = 195,496m3

This is reflected in the pumping data shown earlier, some months are well below average whilst only one month was well above.

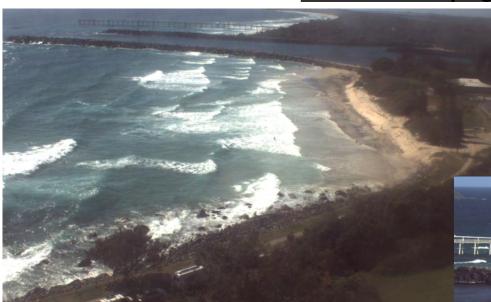
28 December 2020 – After December Erosion

<u>Duranbah Pumping March – July 2021</u>

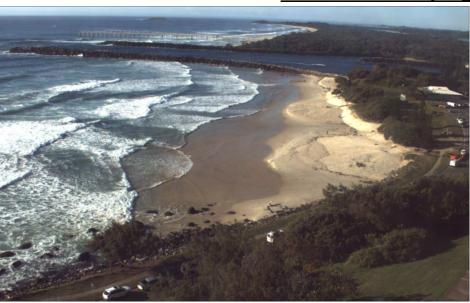
8 May 2021 (central and northern placement)

Duranbah Pumping March – July 2021

Photo in top left is during nourishment in May showing targeted placement areas. Photo in bottom right hand corner is the day after Duranbah completion illustrating a nourished upper beach.

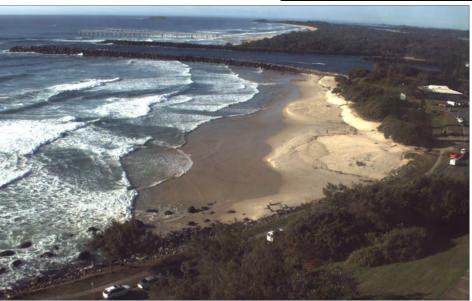
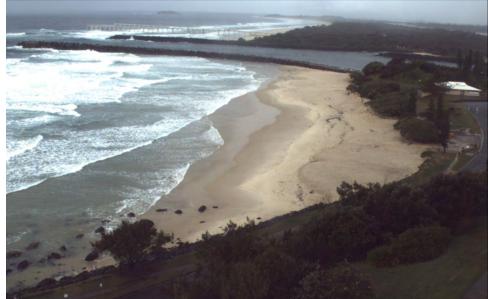
<u>Duranbah Pumping March – July 2021</u>

8 May 2021 (central and northern placement)

2 July 2021 (campaign complete)

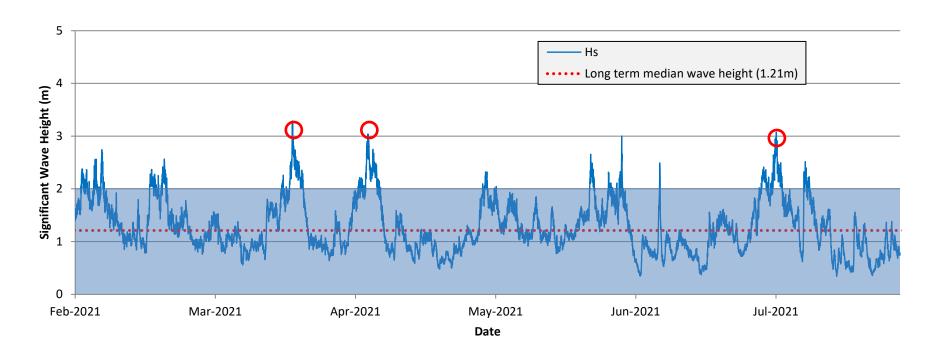
Wave Data – Feb 2021 to Aug 2021

Wave conditions over the last 6 months have been relatively mild. Although there have been 3 or 4 notable swell events, they have been short lived and not significant in size.

Where there was some swell, surf amenity has been excellent, especially at Kirra.

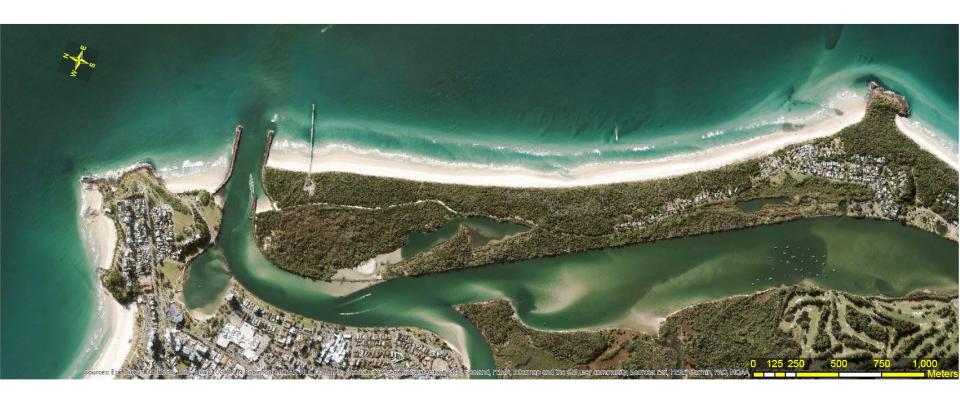
Fingal Head to Point Danger - 4 June 2021

The previous slide shows vertical imagery from Nov 2020 and the current slide is more recent from June 2021.

Notable changes include:

- Fingal bypassing a sand slug has moved around the headland covering the bedrock at the southern end of Letitia
- There is a well defined bar along the length of Letitia that extends to the end of the southern training wall
- Within the entrance, the southern lobe has pushed further north toward the channel and the entrance bar is visible

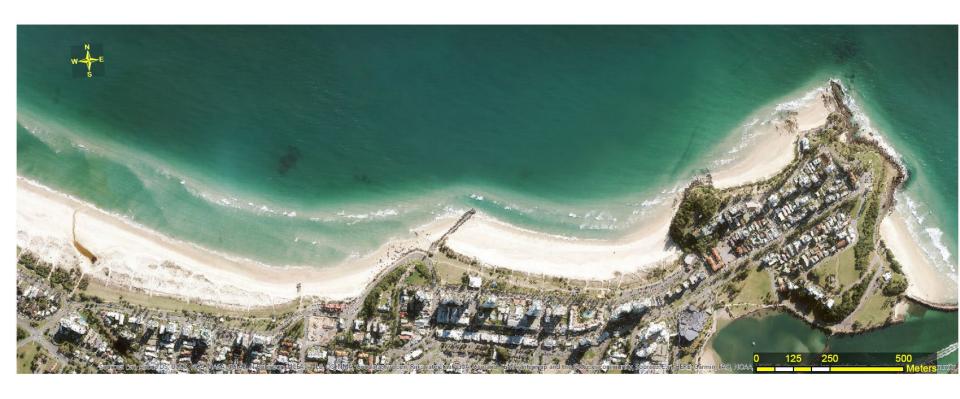
Point Danger to North Kirra - 4 June 2021

Oblique and vertical imagery for Duranbah through to Coolangatta has shown:

- Duranbah beach width increased through pumping and seasonal change
- Sand volumes being restored at Snapper following December erosion event
- Seasonal sand migration through Coolangatta and the subsequent beach rotation
- Sand volumes at Kirra beach and along the lee side of Kirra Point groyne increased
- A defined sediment pathway consistent with seasonal wave climate

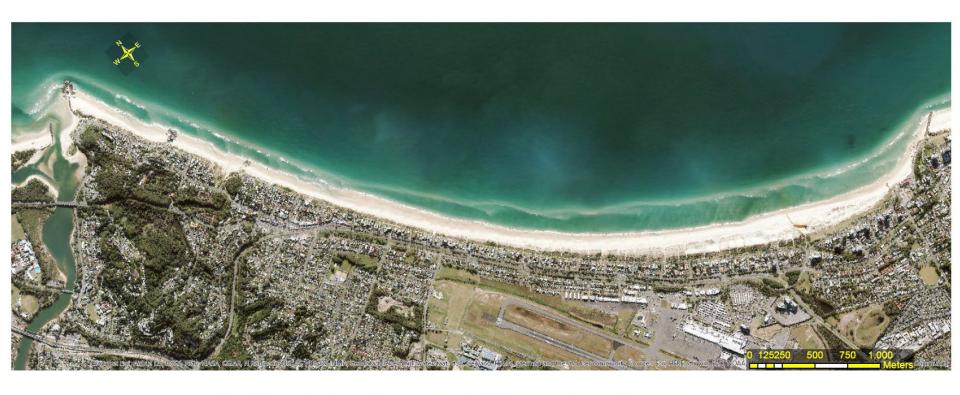
Kirra to Currumbin - 4 June 2021

Well defined bar along the length of Kirra to Currumbin is visible.

Some reduction in upper beach sand volumes at Tugun/Currumbin with some exposure of Flat Rock

2020 Bilinga sand placement mound appears to have dispersed, however the bathymetry of the area shows signs of the placement's influence

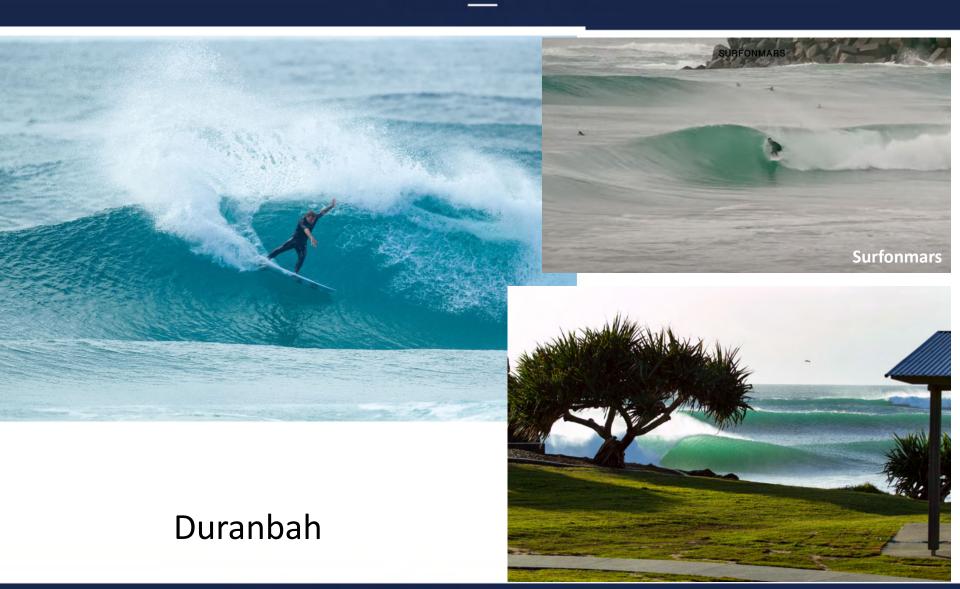
Duranbah has remained consistent with a range of banks across the beach. Sand pumping to Duranbah was not observed to cause any deterioration of bank quality.

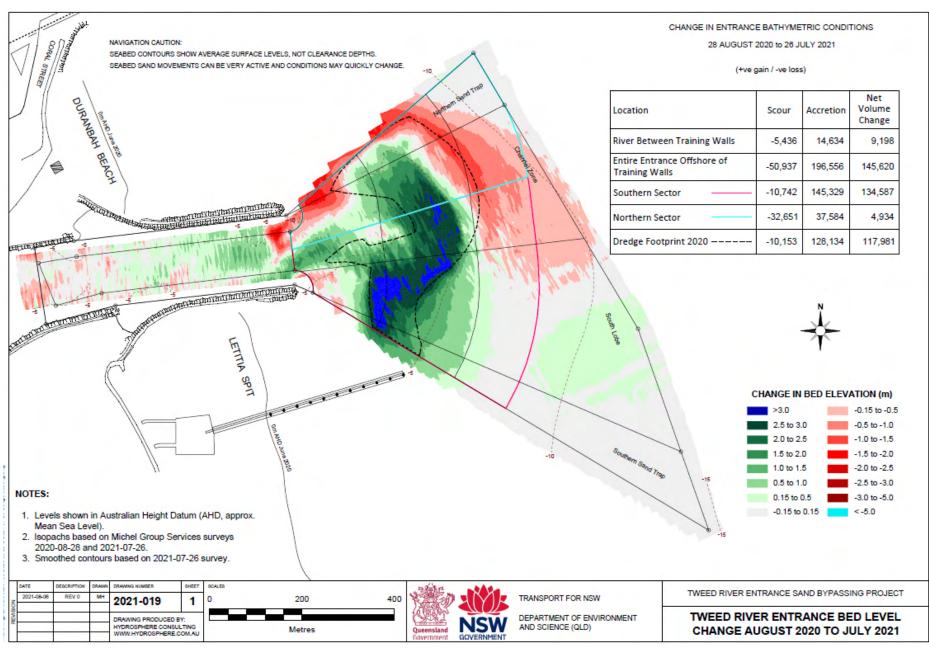
TWEED RIVER ENTRANCE BED LEVEL CHANGE AUGUST 2020 TO JULY 2021

CHANGE IN ENTRANCE BATHYMETRIC CONDITION

28 AUGUST 2020 to 26 JULY 2021

(+ve gain / -ve loss)

Location	Scour	Accretion	Net Volume Change	
	River Between Trainin	-5,436	14,634	9,198	
	Entire Entrance Offsho Training Walls	-50,937	196,556	145,620	
	Southern Sector		-10,742	145,329	134,587
dredge			-32,651	37,584	4,934

Dashed black outline represents the dredge cut area from August 2020. As expected it has infilled due to it being a low point in the sediment pathway. Greens and blues show an increase in level between the surveys nominated, red shows a reduction in level.

Outside of the dredge cut area it is closer to a balance of infill/scour although the slow growth of the ebb tide delta continues

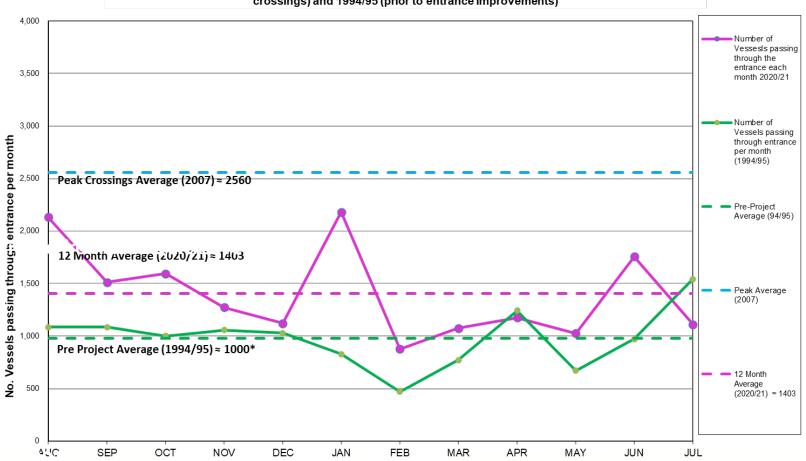
Tweed River Entrance Usage up to August 2021

Comparison of the number of vessels passing through the entrance per month 2020/21 compared to 2007 (peak crossings) and 1994/95 (prior to entrance improvements)

*Note 1 - Assuming the number of incoming boats = outgoing boats in 94/95

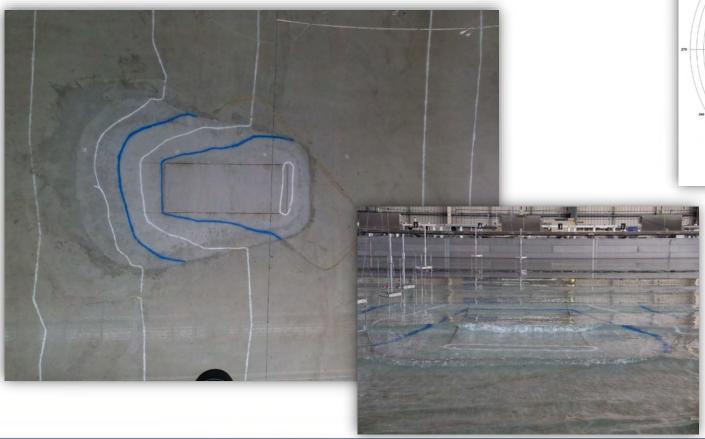
2021 May – 2021 Jul Bilinga wave buoy

- Physical testing final design in the basin
- Deployment of wave buoy at Bilinga

QGHL have continued to develop and test physical model configurations of the proposed Bilinga sand placement design. These images show the bathymetry in the basin and an example of wave transformation over the mound.

A wave buoy has been deployed at Bilinga and some recent data has been collected. This week additional instrumentation will be deployed in the surf zone for a short period of time to measure baseline wave transformation data prior to placement in Aug/September 2021
