ENVIRONMENTAL MONITORING SUMMARY – OCTOBER 2022

1. SAND PUMPING & DREDGING

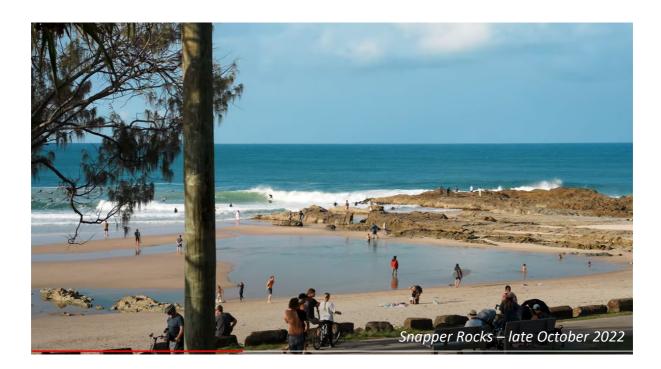
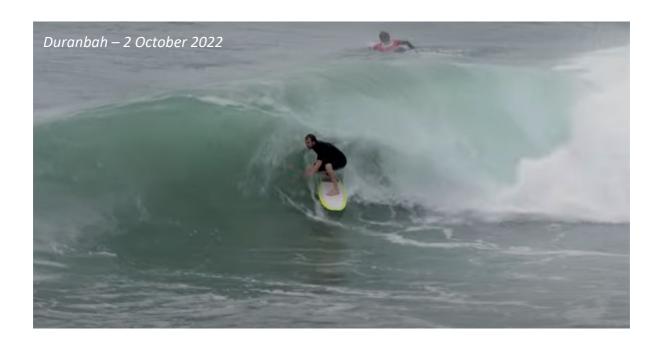
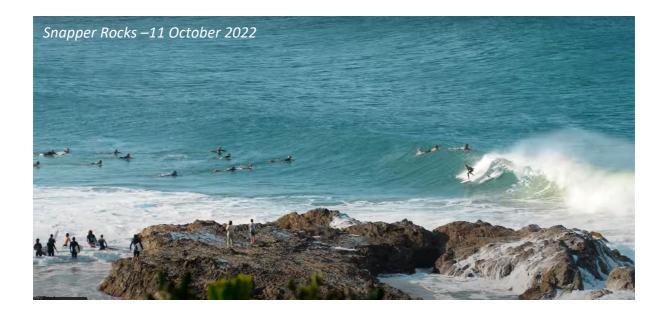
Duranbah beach held up well following the easterly swell considering some scarping was evident along the length of the beach and rocks at the northern end were more exposed. The north facing beaches at Greenmount and Kirra did recede but should quickly recover as sand supply has been relatively high due to recent conditions.

Surf conditions were generally good during October with quality sand banks at Duranbah and Snapper Rocks. Snapper Rocks suffered erosion behind the rocks following the late October swell.
