# TWEED RIVER ENTRANCE SAND BYPASSING PROJECT

## THE PROJECT

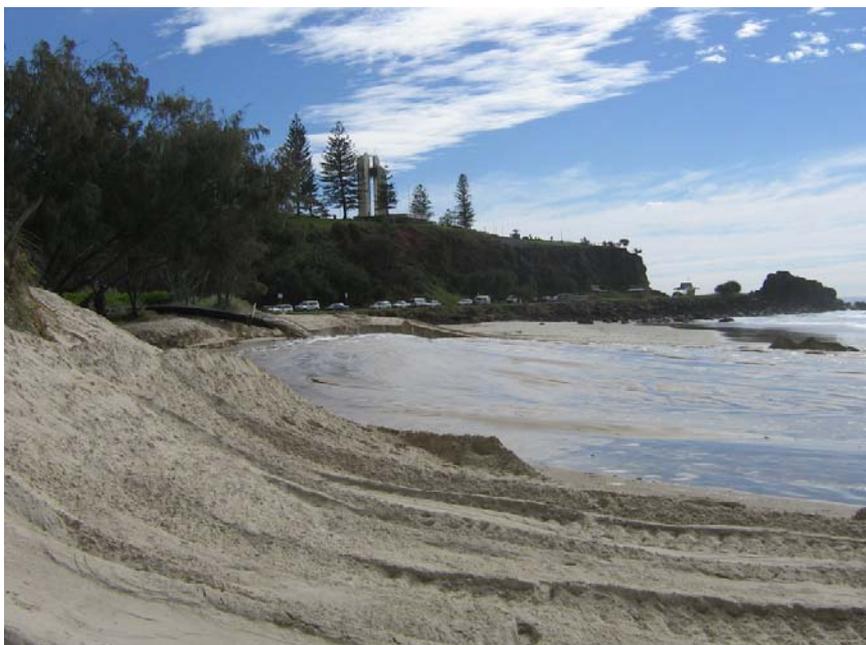
DURANBAH BEACH DURING RESTORATION - Photo by Ian Taylor

To compensate for the reduced natural flow of sand onto Duranbah Beach, the project supplies sand to the beach whenever necessary to ensure there is a useable beach and good surfing shoals. The dunes at the rear of the beach were enlarged in May last year and further sand was placed on the upper beach in December. This trial sand placement was undertaken in conjunction with Tweed Shire Council to examine the viability of this approach. It was reasonably successful in providing an increased storm buffer and an improved beach amenity. The enlarged dunes were badly eroded in March and restored again in April/May this year. The project has liaised with Tweed Shire Council to assist it in the preparation of a management strategy for the area.
